Manhole Inspection Summary

Manhole # S09QQ_015MH

Location Address: **3413 BATEMAN AVE**

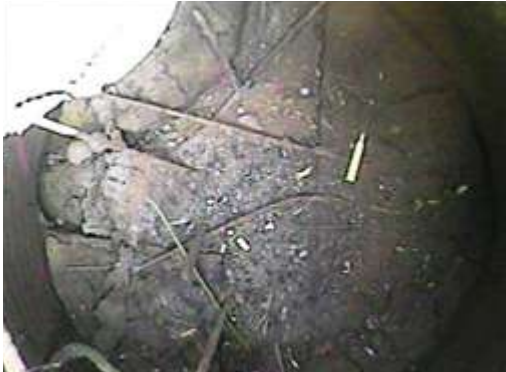
Defect 1

Condition: ☐ Sound ☐ Cracked ☐ Root Intrusion ☐ Deteriorated ☐ Leaks ☒ **Debris**

DEBRIS IN CHANNEL AND BENCH

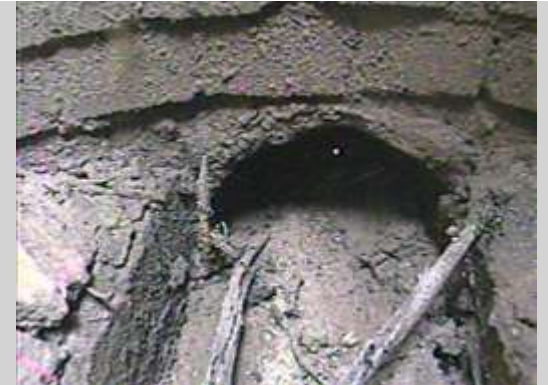
12 O'Clock Outflow

8 in. Circular Gravity Sewer
Pipe Out @ 12 O'Clock

Pipe Height: (in.) Direct
Pipe Material: **Clay** ☐ Pipe Lined
Invert Depth: **5.29** (ft.) Flow Characteristics: **None**
Deposits: ☐ None ☒ **Mud** ☐ Sludge ☒ **Debris** ☐ Grease
Silt Depth: **6** (in.) Deposits Extent: **Heavy**
Infiltration: **None** Pipe Seal Cond: **Unknown**

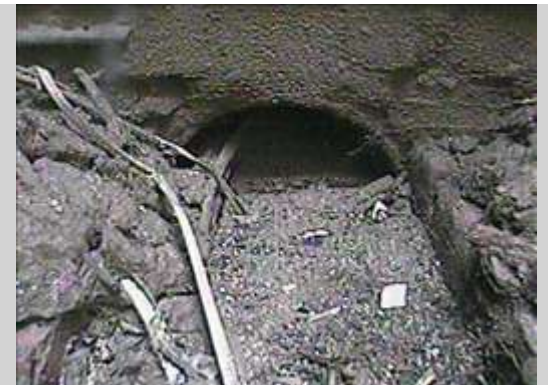
6 O'Clock Inflow

8 in. Circular Gravity Sewer
Pipe In @ 6 O'Clock

Pipe Height: (in.) Direct
Pipe Material: **Clay** ☐ Pipe Lined
Invert Depth: **5.25** (ft.) Flow Characteristics: **None**
Deposits: ☐ None ☒ **Mud** ☐ Sludge ☒ **Debris** ☐ Grease
Silt Depth: **6** (in.) Deposits Extent: **Heavy**
Infiltration: **None** Pipe Seal Cond: **Unknown**

Connects To: **Stub connection / abandoned**

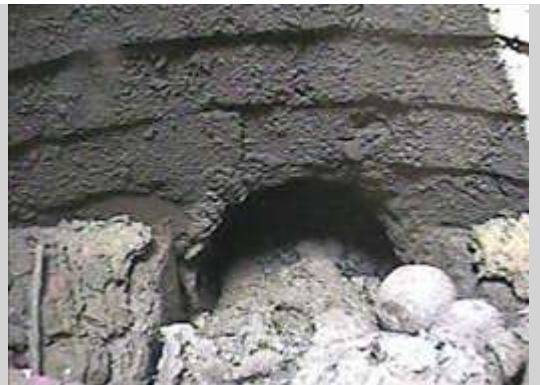
9 O'Clock Inflow

6 in. Circular Gravity Sewer

Pipe In @ 9 O'Clock

Deposits: ☐ None ☒ **Mud** ☐ Sludge ☒ **Debris** ☐ Grease

Silt Depth: **6** (in.) Deposits Extent: **Heavy**

Connects To: **Stub connection / abandoned**
